Debris/Ice/TPS Assessment and Integrated Photographic Analysis of Shuttle Mission STS-79

**DEBRIS/ICE/TPS ASSESSMENT
AND
INTEGRATED PHOTOGRAPHIC ANALYSIS
OF
SHUTTLE MISSION STS-79**

16 September 1996

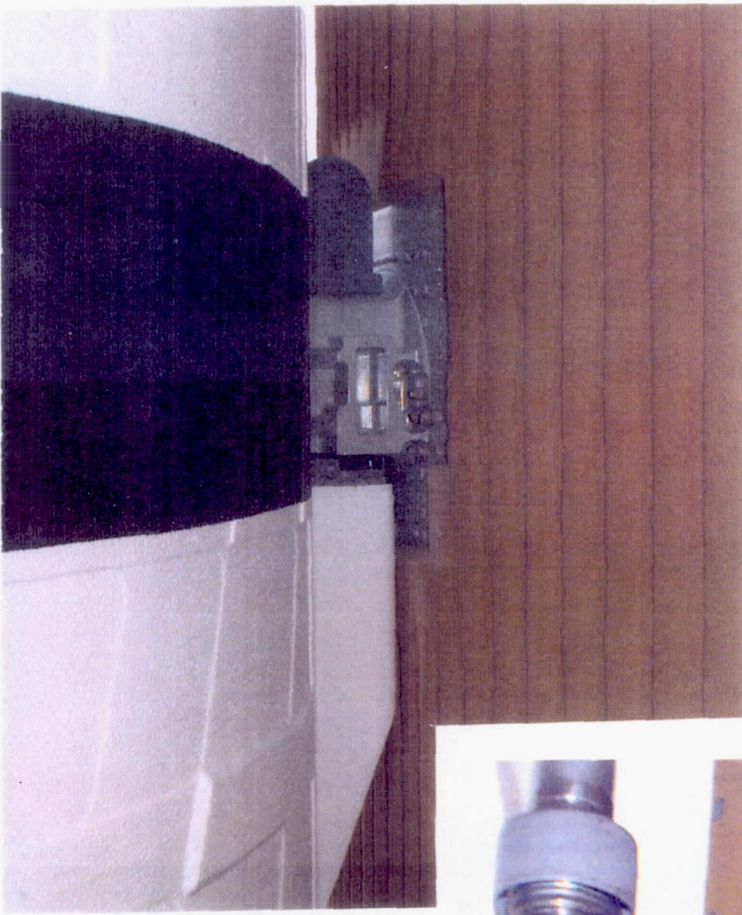
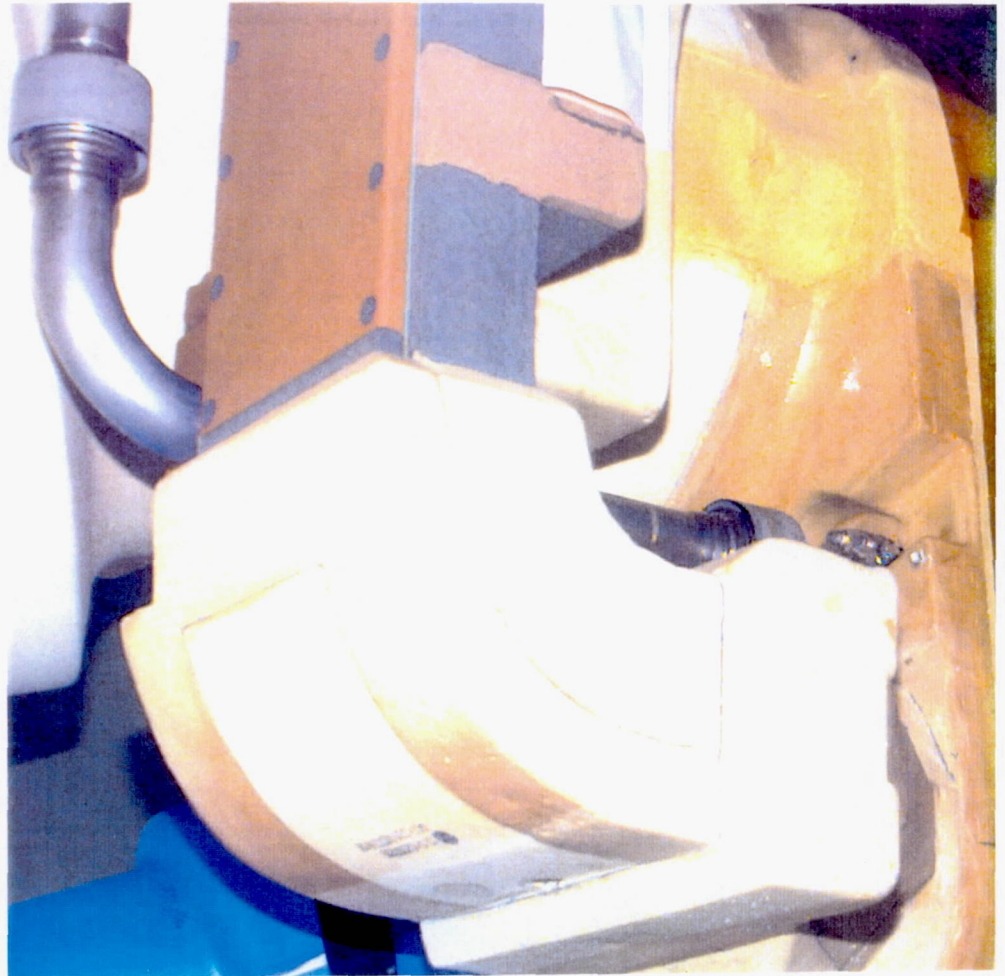
Photo 2: SRB/ET Bolt Catcher and ET LH2 Umbilical Cable Tray

As a weight-savings measure and process improvement, topcoat (Flame Retardant Latex) was not applied to the ET/SRB Bolt Catcher and the ET LH2 Umbilical Cable Tray.

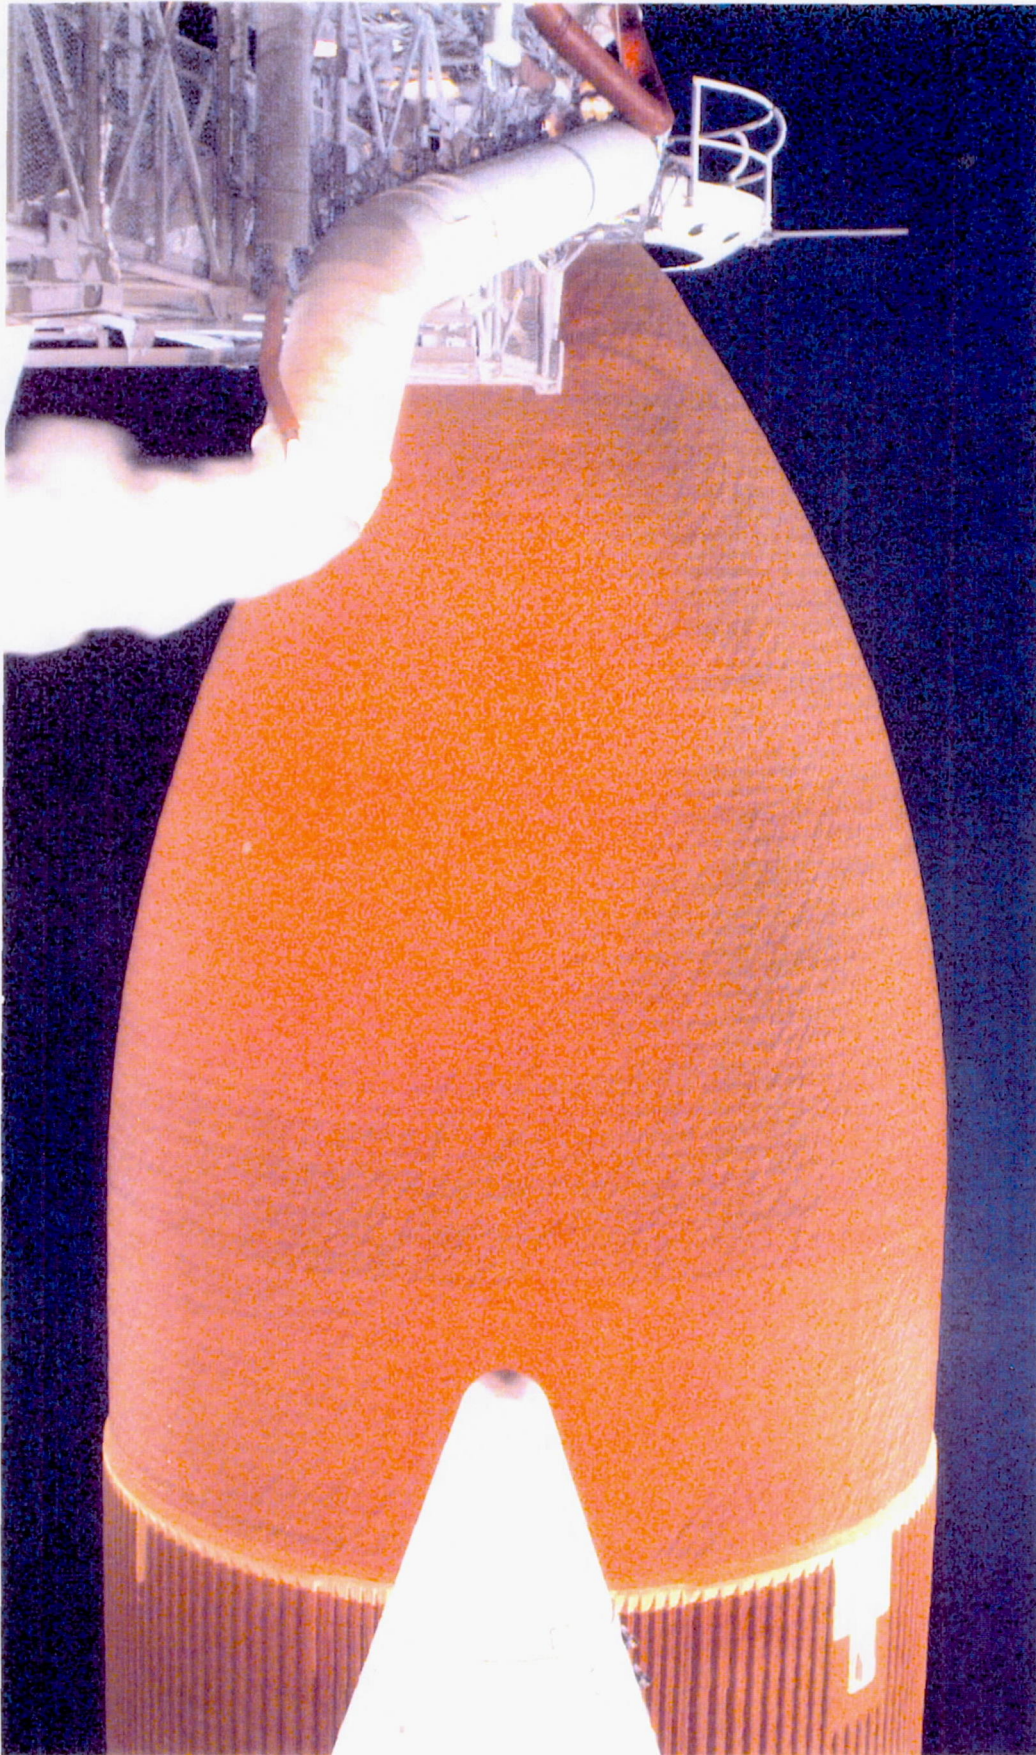
Photo 3: ET LO2 Tank

The Final Inspection Team observed light condensate, but no ice or frost accumulations, on the LO2 tank. TPS surface temperatures ranged from 67-71 degrees F.

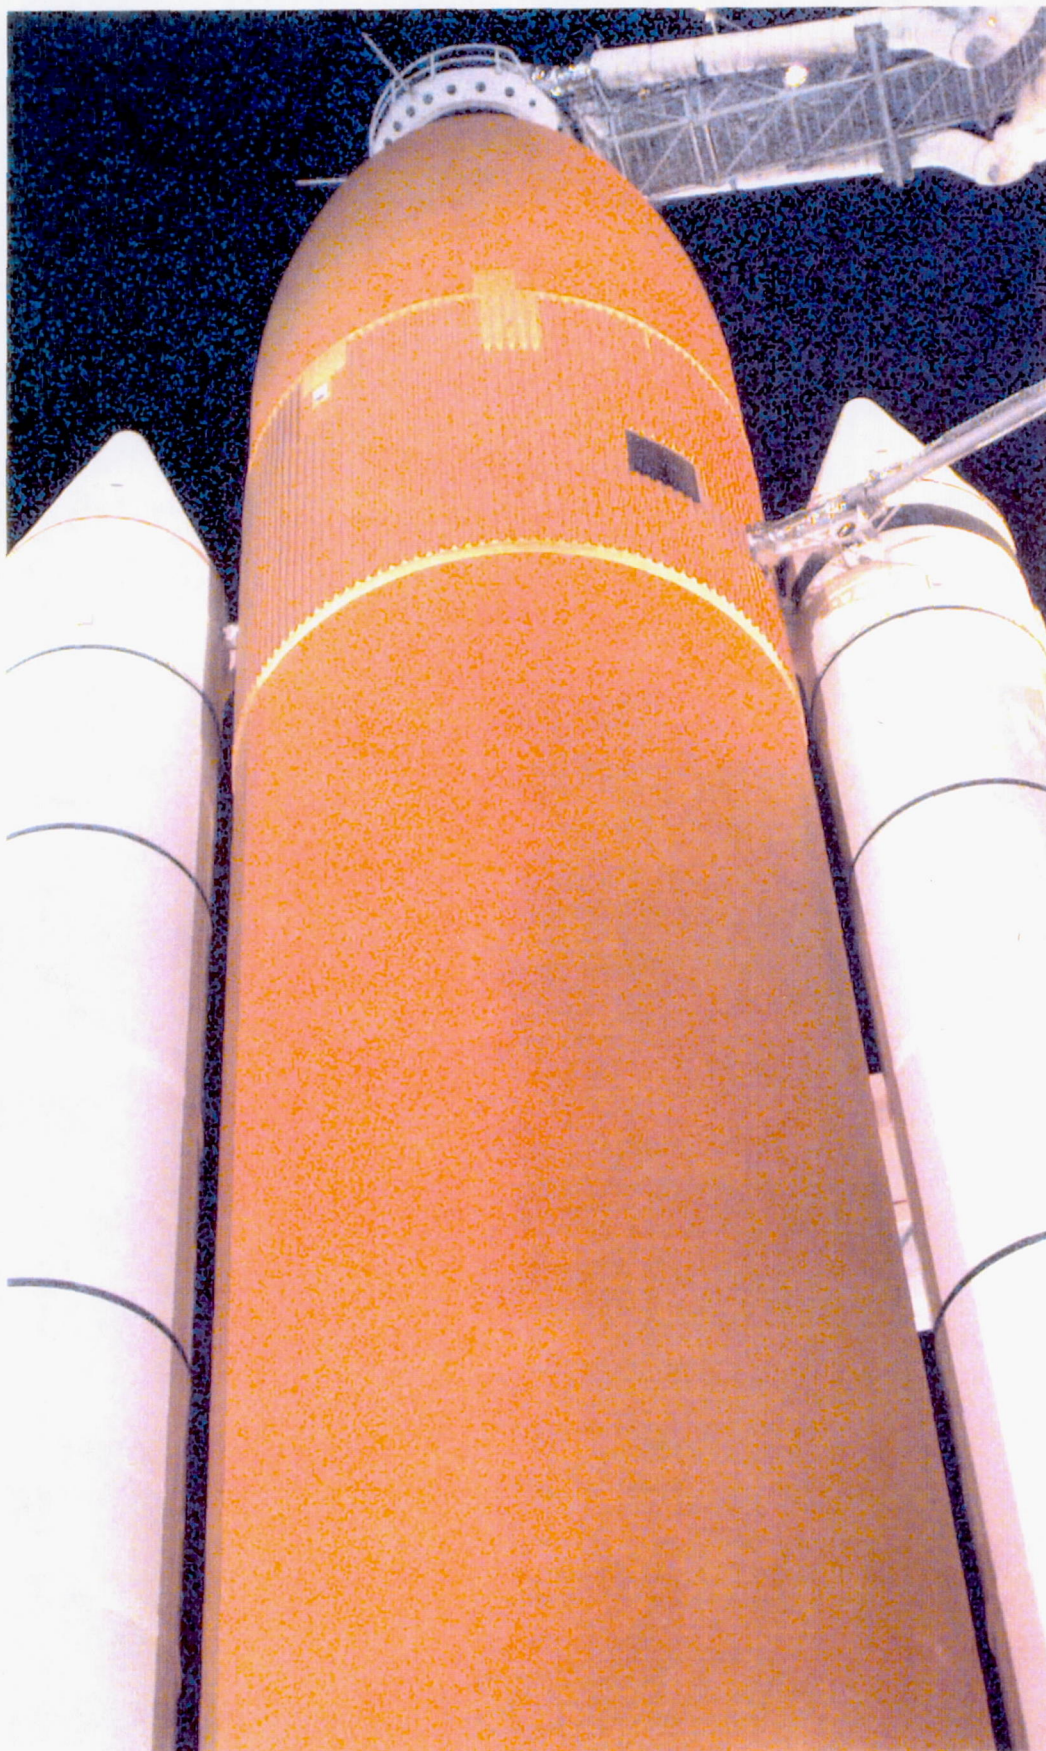
Photo 4: ET Cryoloaded for Launch

There were no LH2 tank TPS acreage anomalies. Light condensate, but no ice or frost accumulation, was present on the acreage. TPS surface temperatures ranged from 77-79 deg. F. ET-82 was the first flight that utilized the new composite Intertank door.

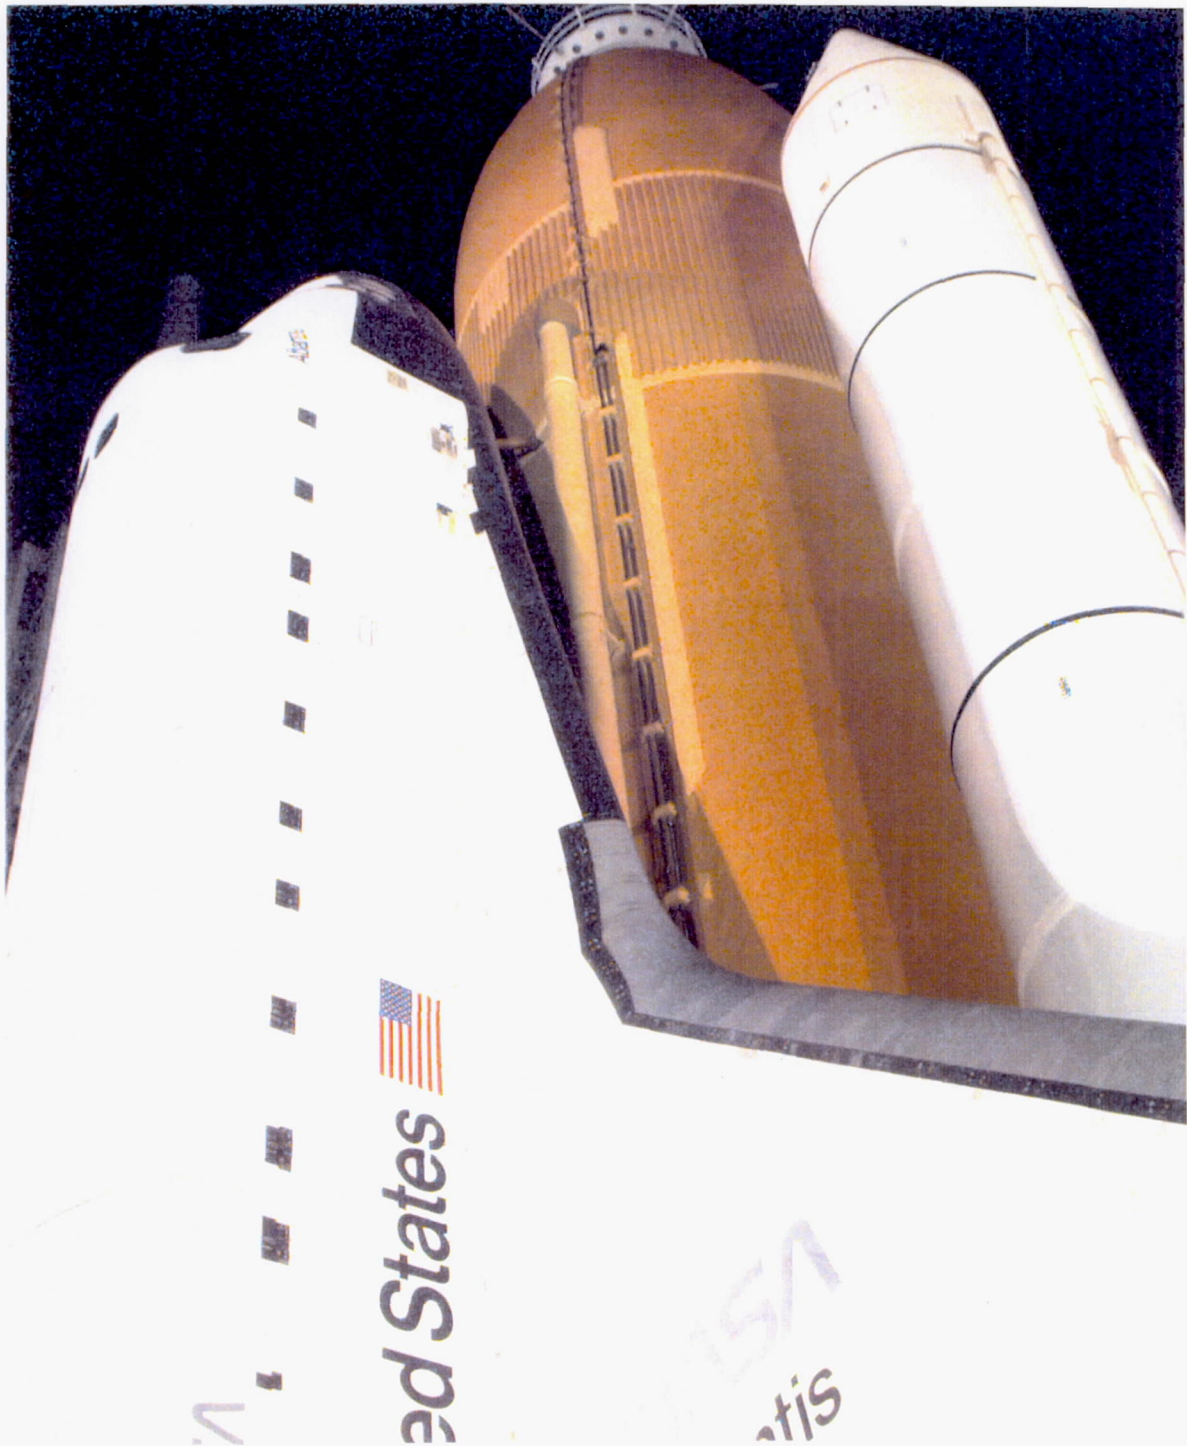
Photo 5: STS-79 Cryoloaded for Launch
OV-104 Atlantis (20th Flight), ET-82 (LWT 75), and BI-083 SRB's

There were no LH2 tank TPS acreage anomalies. Light condensate, but no ice or frost accumulation, was present on the acreage. TPS surface temperatures ranged from 77-79 degrees F. There were no anomalies on the new method bipod jack pad standoff closeouts. A crack, 3-inches long by 1/4-inch wide, was present in the -Y vertical strut attachment fitting fairing forward surface TPS. The presence of the crack was acceptable for flight per NSTS-08303 criteria.

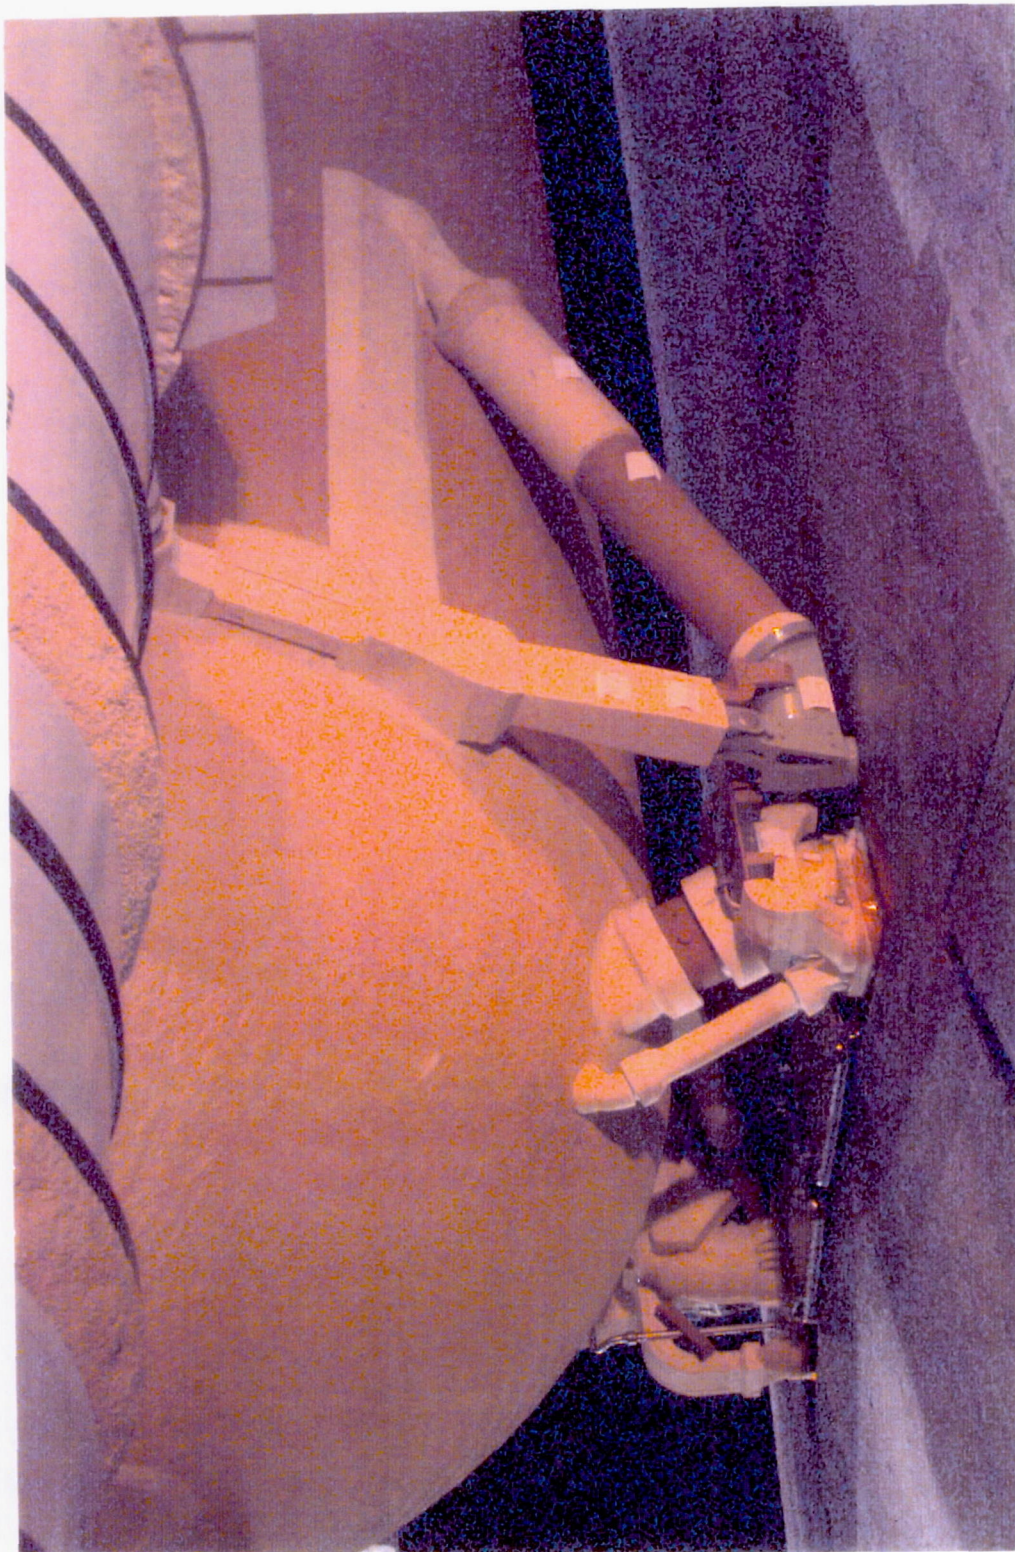
Photo 6: ET/ORB Umbilicals

Less than usual amounts of ice/frost had accumulated on the LH2 ET/ORB umbilical purge barrier top and outboard sides. No unusual vapors or cryogenic drips had appeared during tanking, stable replenish, and launch.

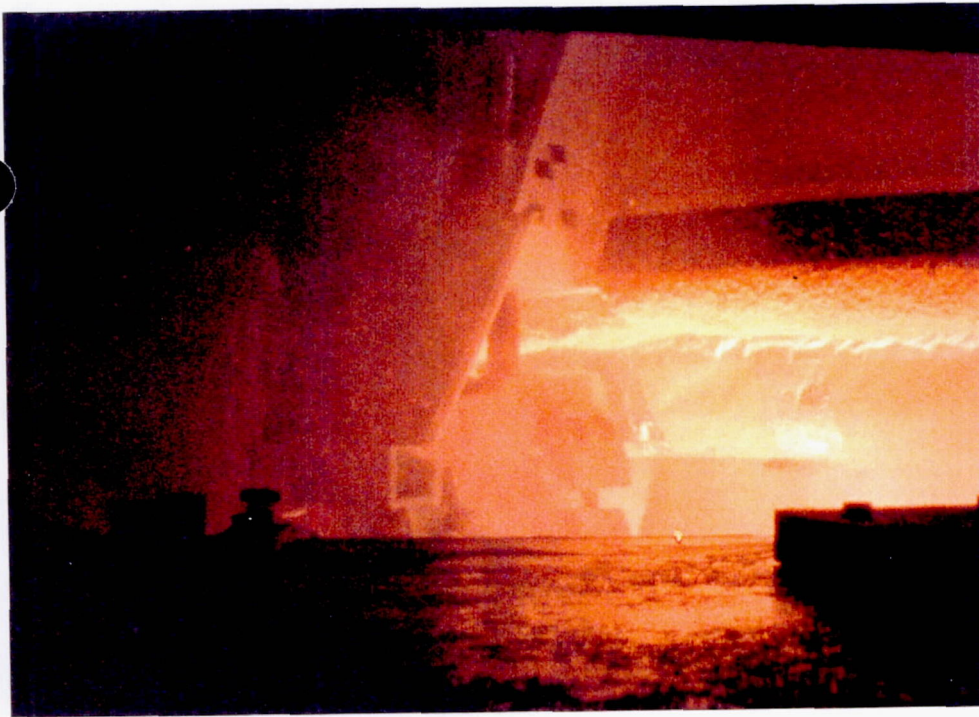
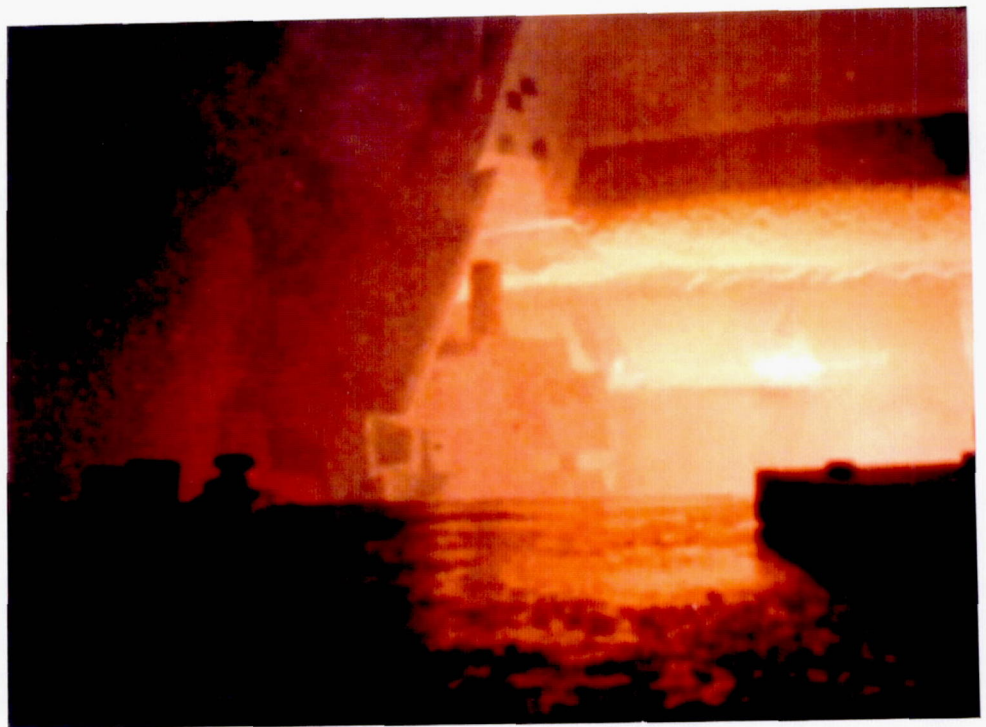
Photo 8: Stud Hang-up

A stud hang-up occurred on holddown post #3. No ordnance fragments or frangible nut pieces fell from the DCS while in the field of view.

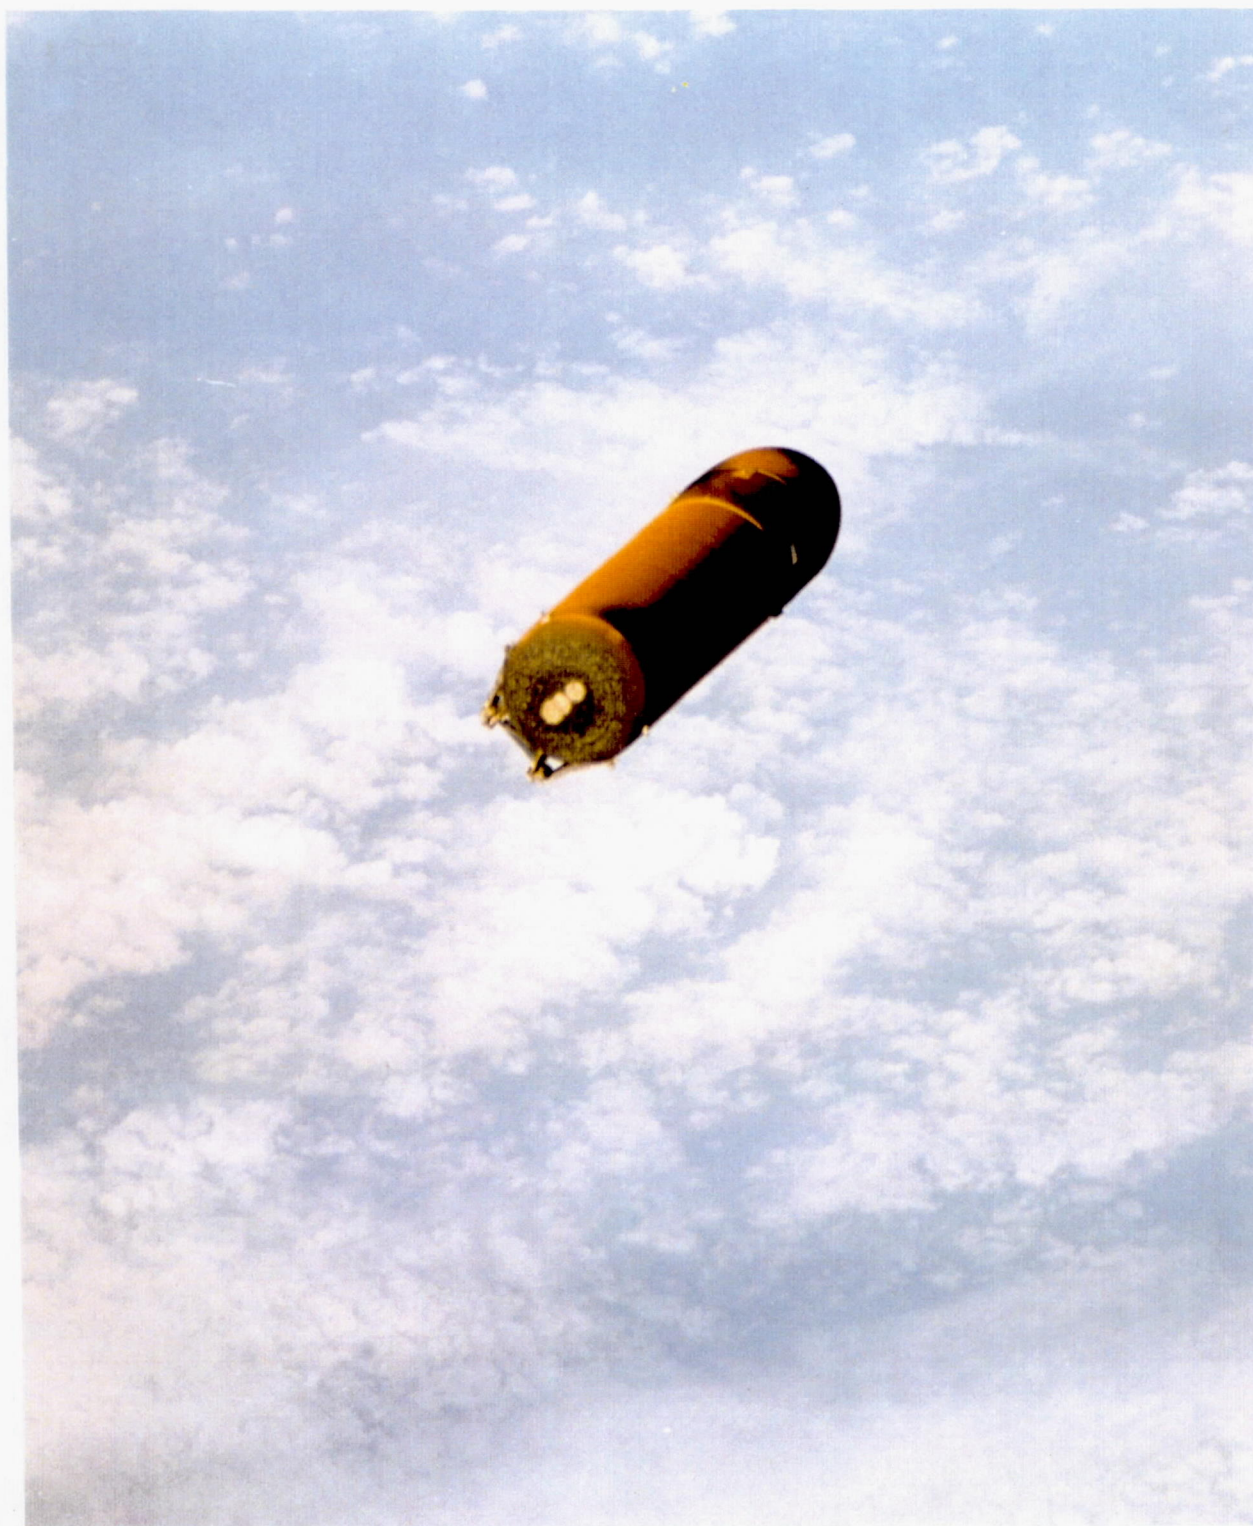
Photo 9: ET After Separation

The aft dome exhibited numerous small "popcorn" type divots/erosion and a mottled charred appearance, none of which were considered anomalous.

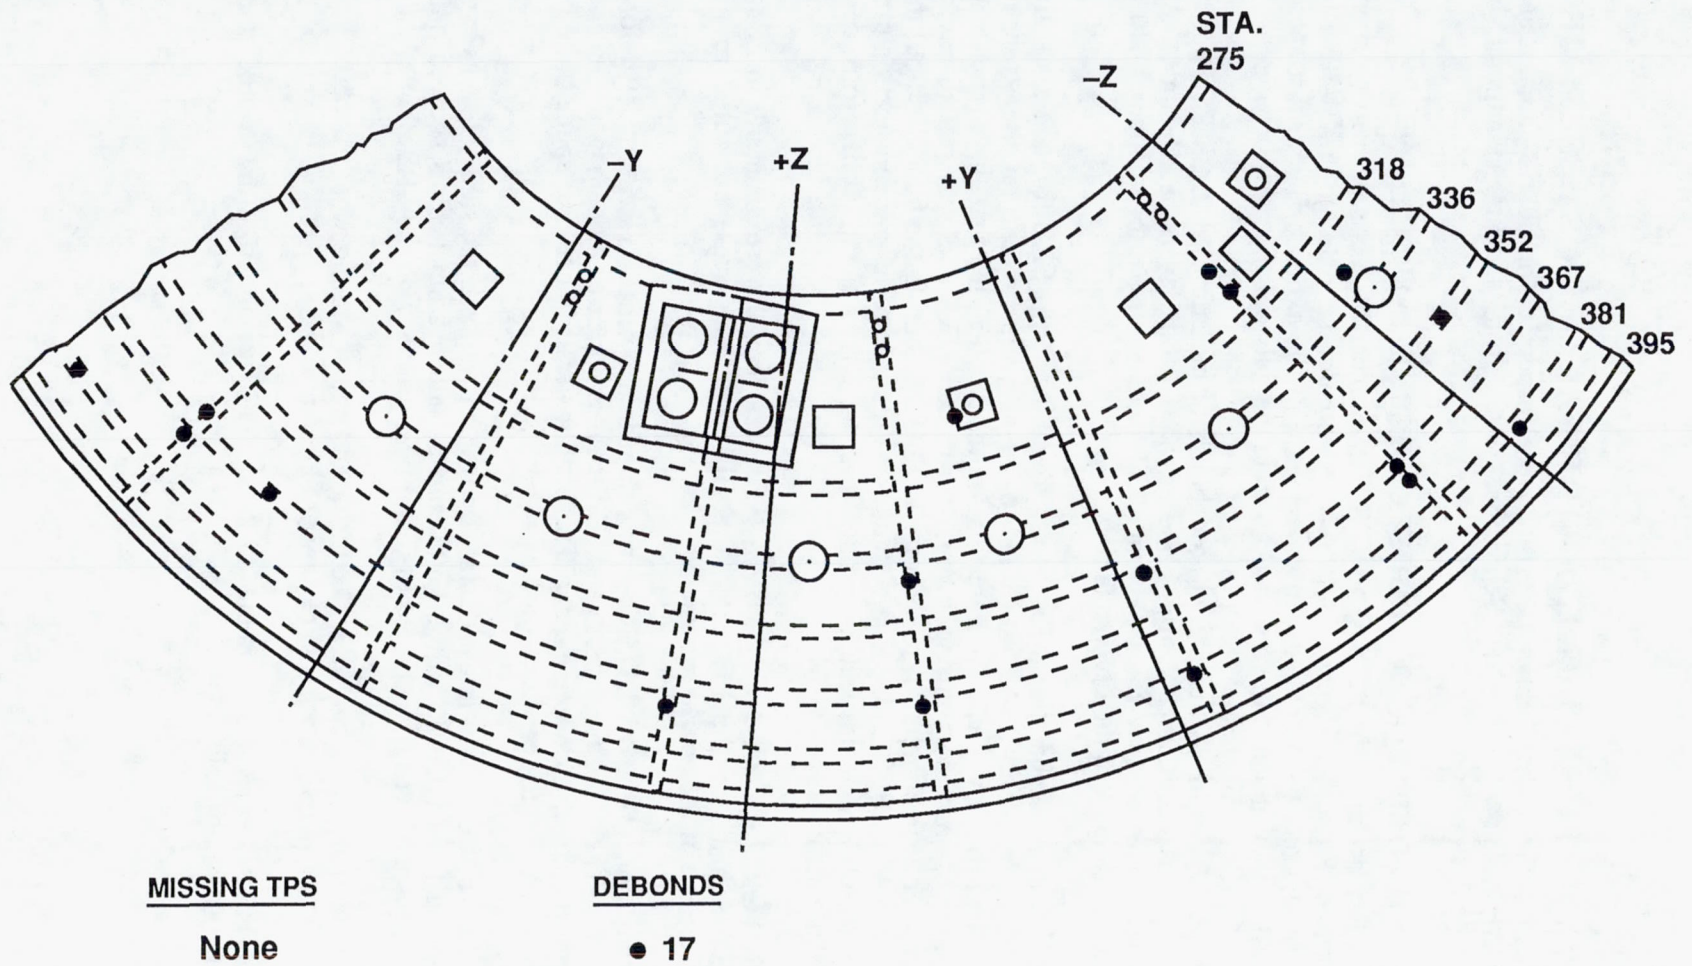
Figure 1: RH SRB Frustum

The RH frustum was missing no TPS. The number of debonds over fasteners (17) was less than average (Figure 1). Hypalon paint was blistered/missing along the XB-395 ring frame where BTA closeouts had been applied. However, most of the exposed BTA substrate was not sooted. The BSM aero heat shield covers had locked in the fully opened position.

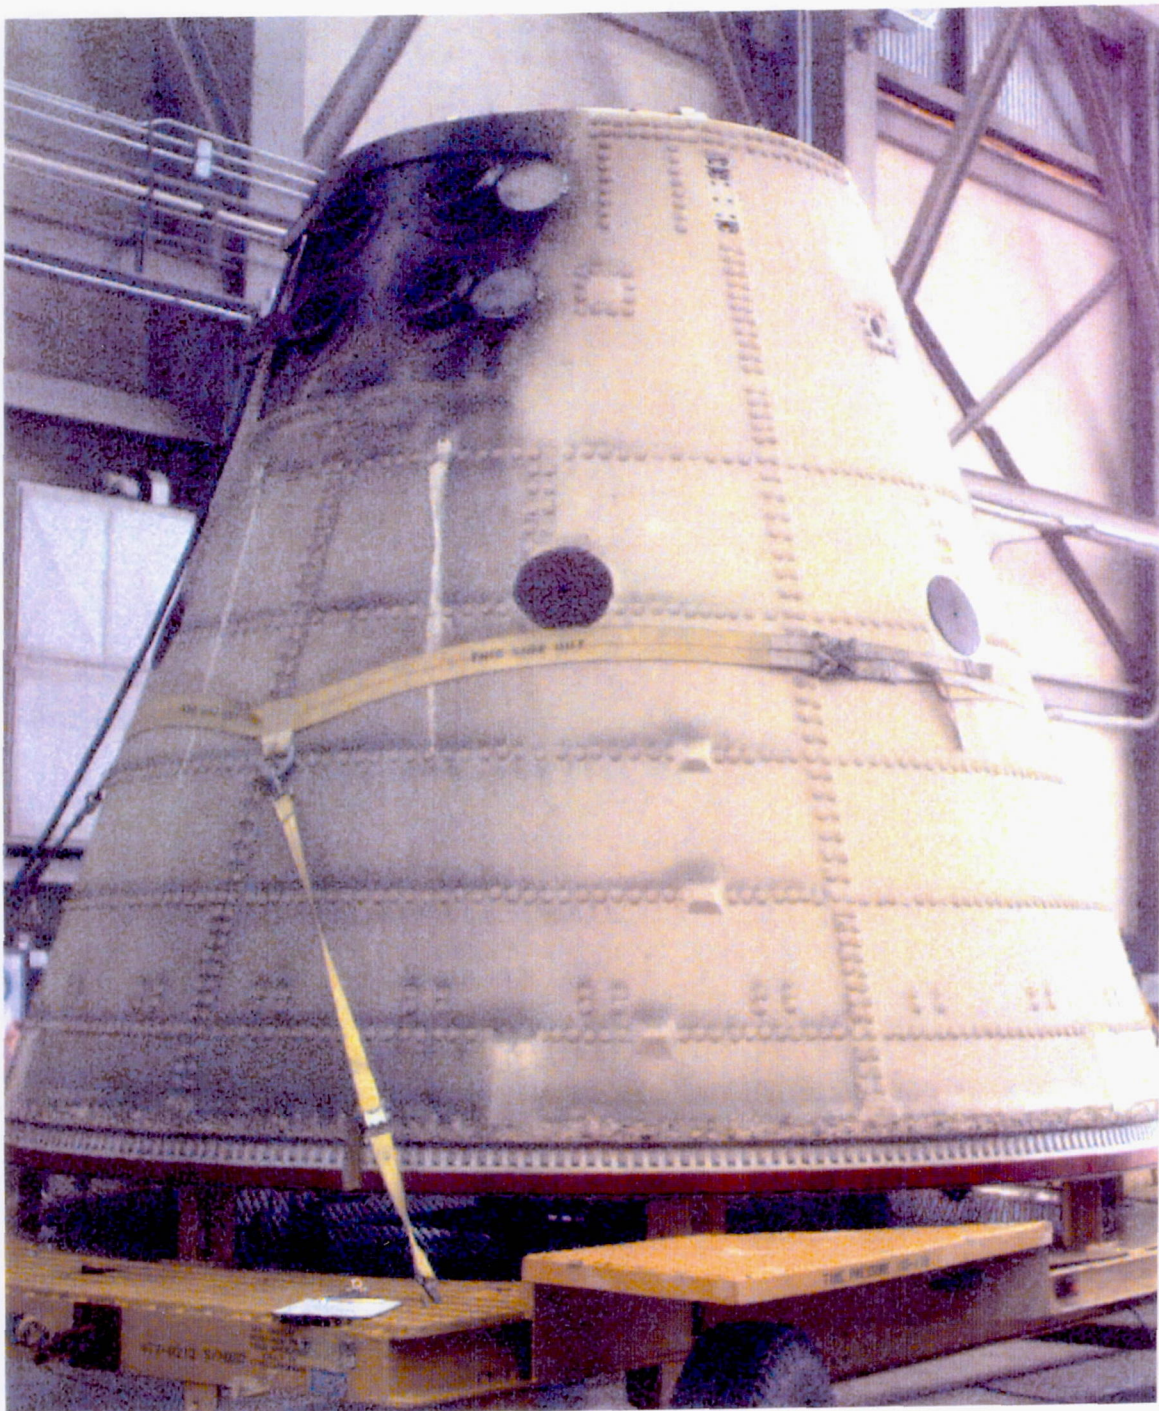
Photo 11: RH Frustum

The RH frustum was missing no TPS. The number of debonds over fasteners (17) was less than average. Hypalon paint was blistered/missing along the XB-395 ring frame where BTA closeouts had been applied. However, most of the exposed BTA substrate was not sooted. The BSM aero heat shield covers had locked in the fully opened position.

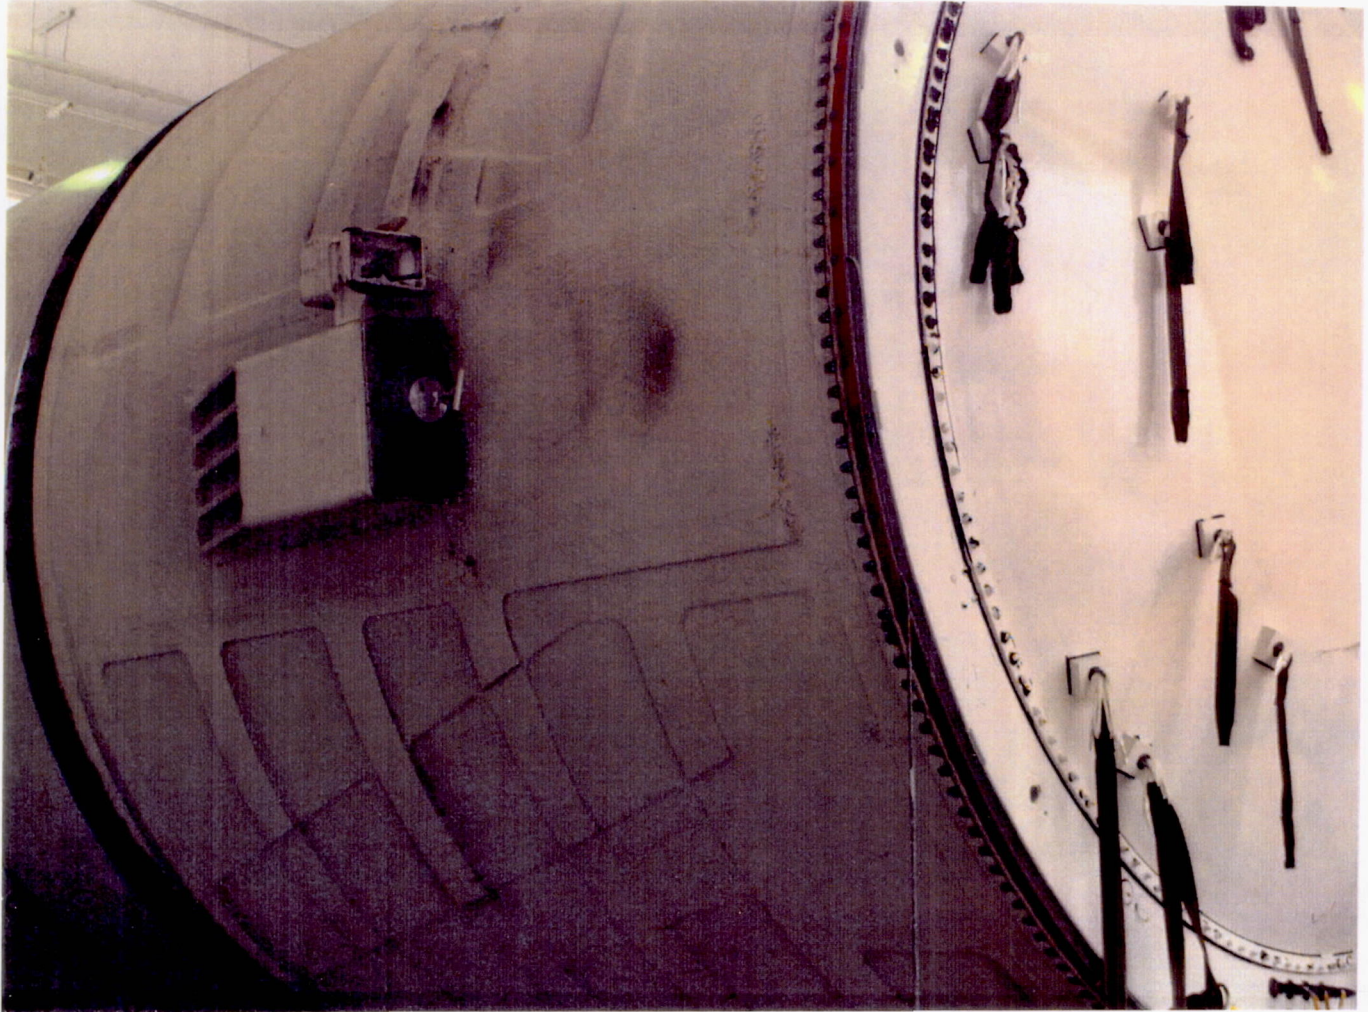
Photo 12: RH Forward Skirt

The RH forward skirt exhibited no debonds or missing TPS. Both RSS antennae covers/phenolic base plates were intact though some of the phenolic layers had delaminated. Hypalon paint was blistered/missing over the areas where BTA closeouts had been applied. No pins or retainer clips were missing from the severance ring.

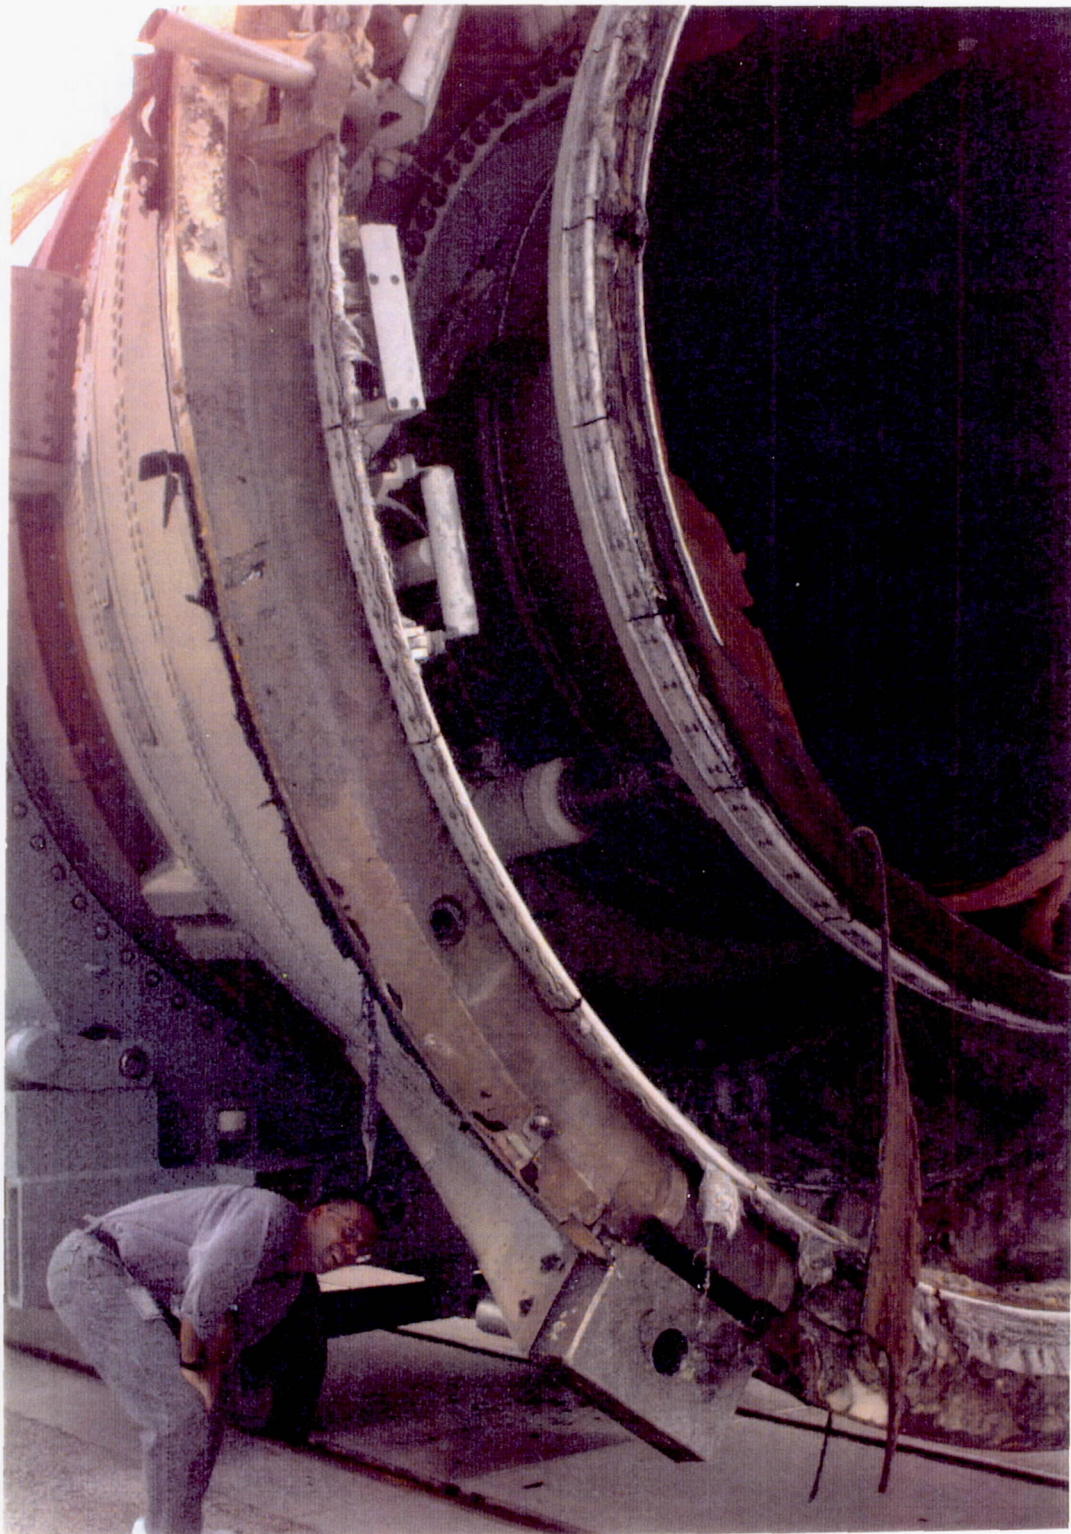
Photo 14: Aft Skirt Aft Ring Missing Foam

Instafoam was missing and the substrate was exposed on the aft skirt aft ring from HDP #2 to the HPU exhaust ducts. Launch films showed numerous light colored particles, believed to be pieces of foam, falling along side the SRB plumes during ascent.

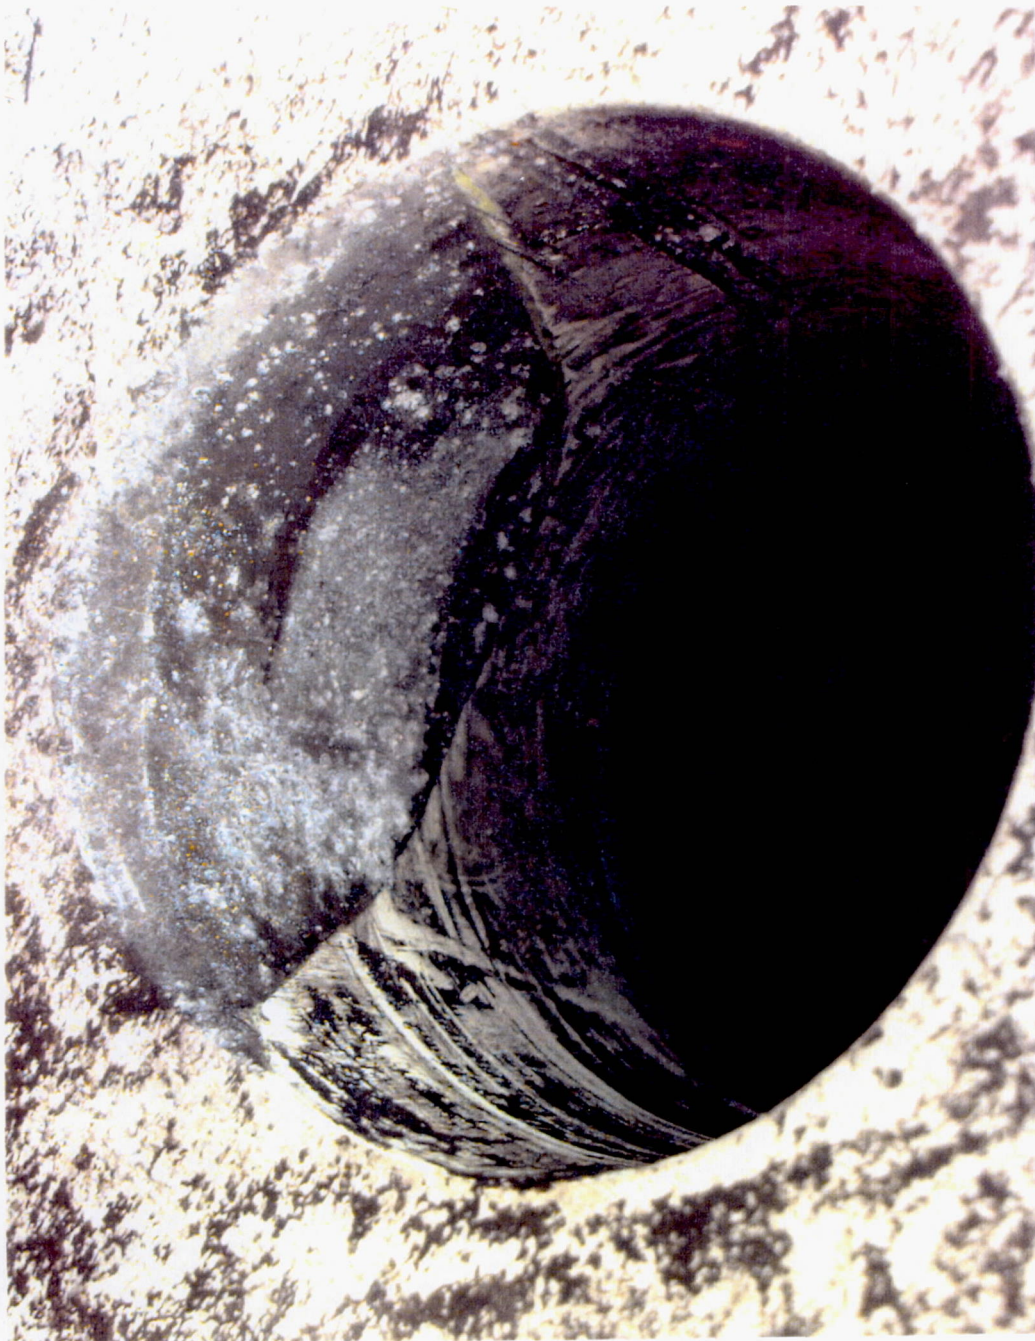
Photo 15: HDP #3 Stud Hole Broaching

A stud hang-up occurred on HDP #3 and the stud hole was broached. The stud hang-up was confirmed in the launch film review.

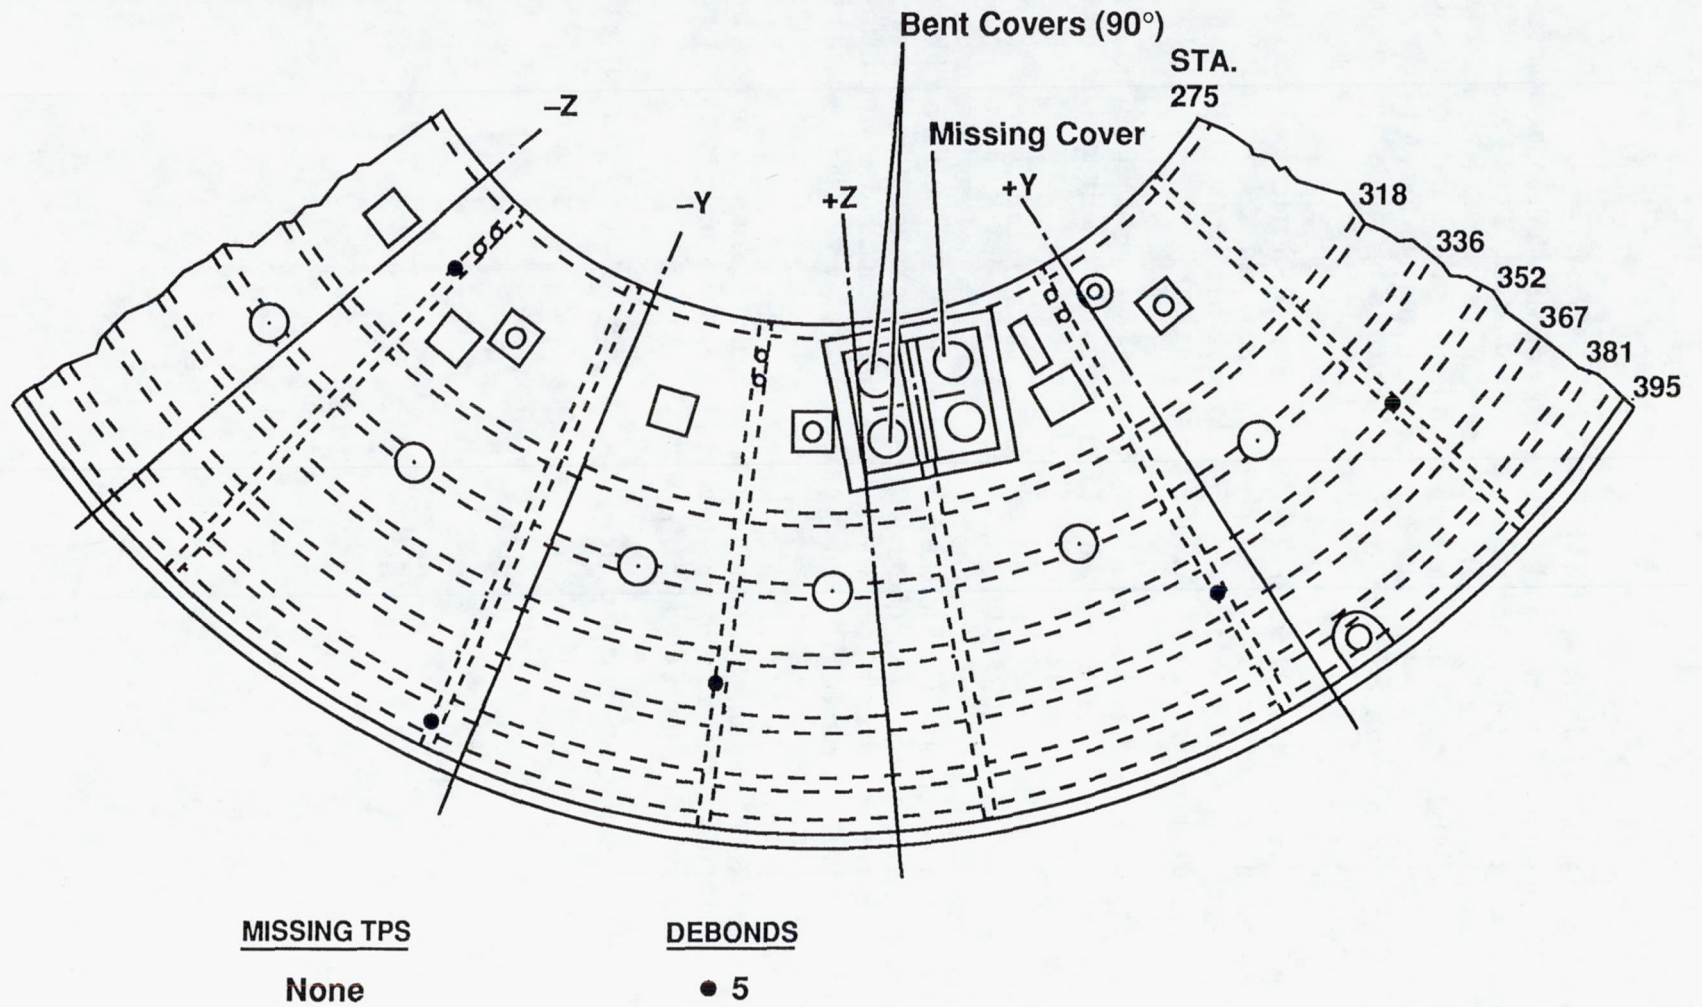
Figure 2: LH SRB Frustum

The LH frustum was missing no TPS. The number of MSA-2 debonds over fasteners (5) was less than average (Figure 2). Hypalon paint was blistered/missing along the XB-395 ring frame where BTA closeouts had been applied. However, most of the exposed BTA substrate was not sooted. The two left BSM aero heat shield covers had been bent by parachute entanglement; the lower right cover was locked in the fully open position, and the forward right cover was missing.
